## EPHRATAH DAM

FULTON COUNTY, NEW YORK  
INVENTORY NO. N.Y. 178

### PHASE I INSPECTION REPORT NATIONAL DAM SAFETY PROGRAM

PHASE 1 INSPECTION REPORT  
NATIONAL DAM SAFETY PROGRAM  
EPHRATAH DAM I.D. No. NY 178  
DEC #456  
MOHAWK RIVER BASIN  
FULTON COUNTY, NEW YORK

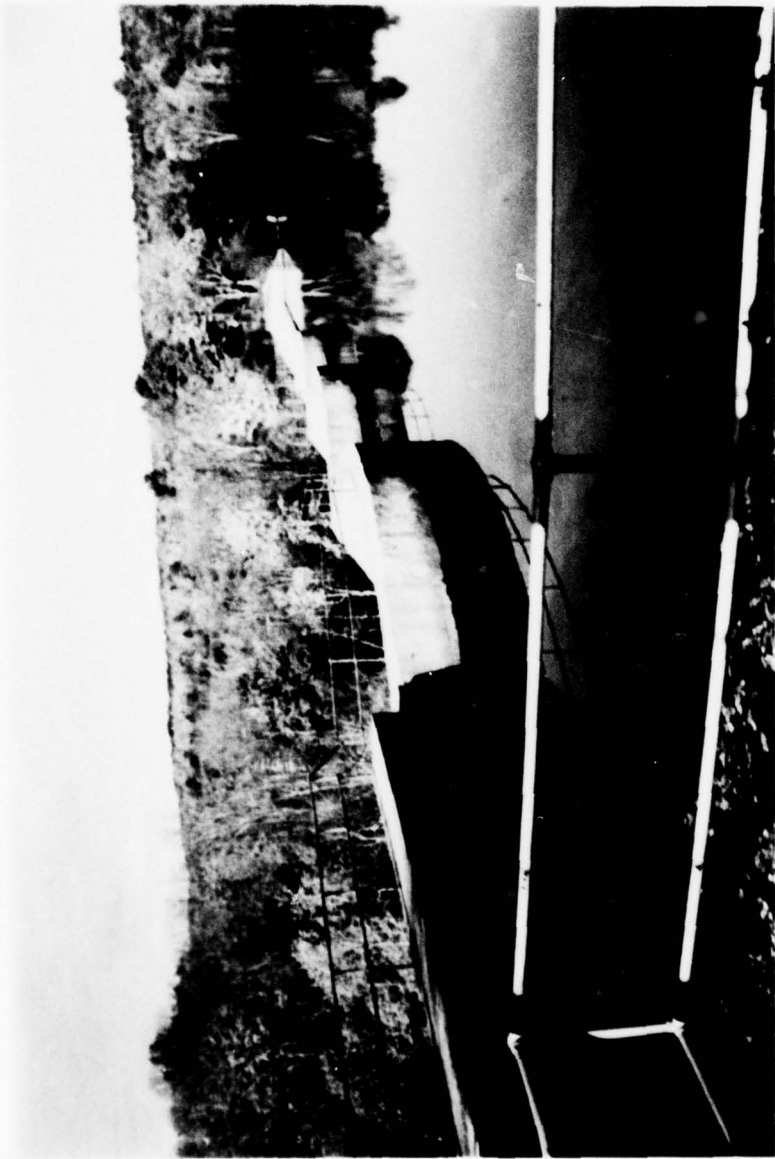
Overview of Ephratah Dam  
Upstream Face Looking North

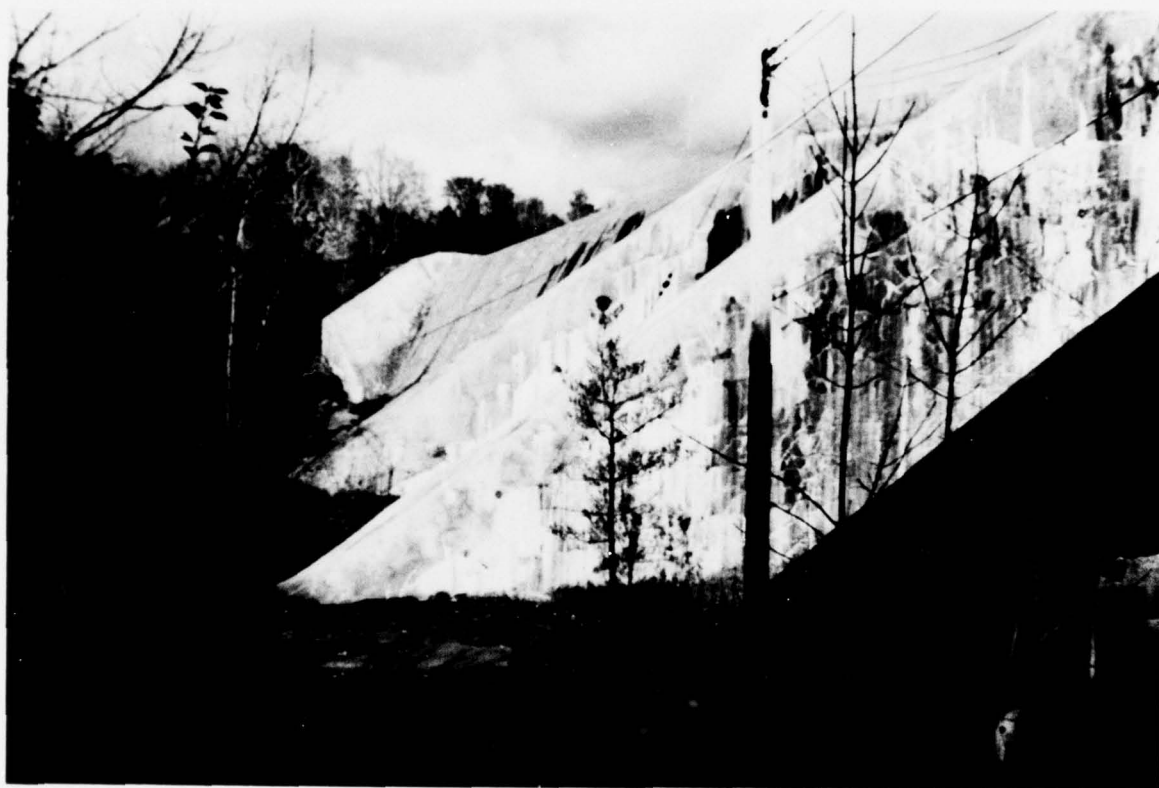
Overview of Ephratah Dam  
Downstream Face Looking North

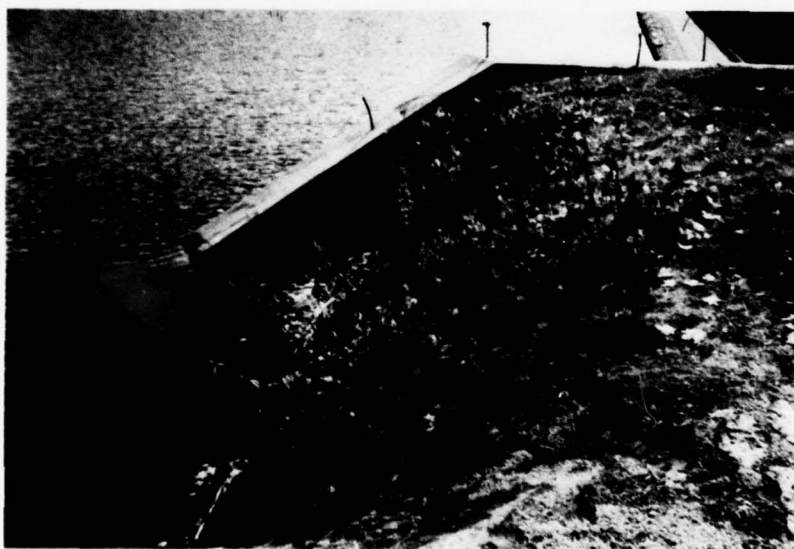
The earth embankment portions show no signs of major distress. However, the following problem areas were observed: Erosion of the upstream face near the north buttress of the spillway is probably due to wave action and the lack of energy dissipating material such as riprap. The void and seepage observed near the toe of the spillway at the north buttress may be related to seepage along the earth-concrete interface or related to seepage from the jointed shale bedrock. The embankment slopes appear to be excessively steep.

Upstream Face of Embankment  
Looking South

2. Repair the erosion on the upstream face of the earth embankment near the north spillway buttress and place erosion protection material. Monitor periodically the void observed at the toe of the north spillway buttress on the downstream face to determine if further movement is occurring.

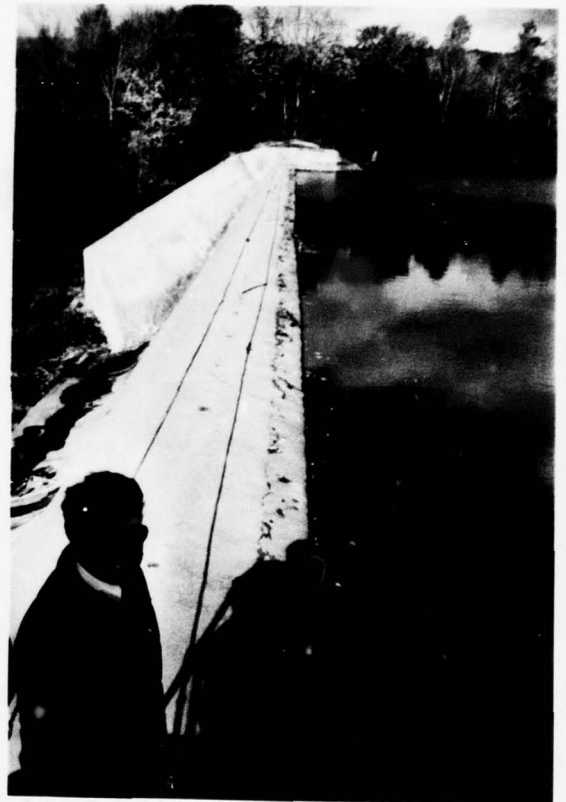
Spillway Crest Looking North

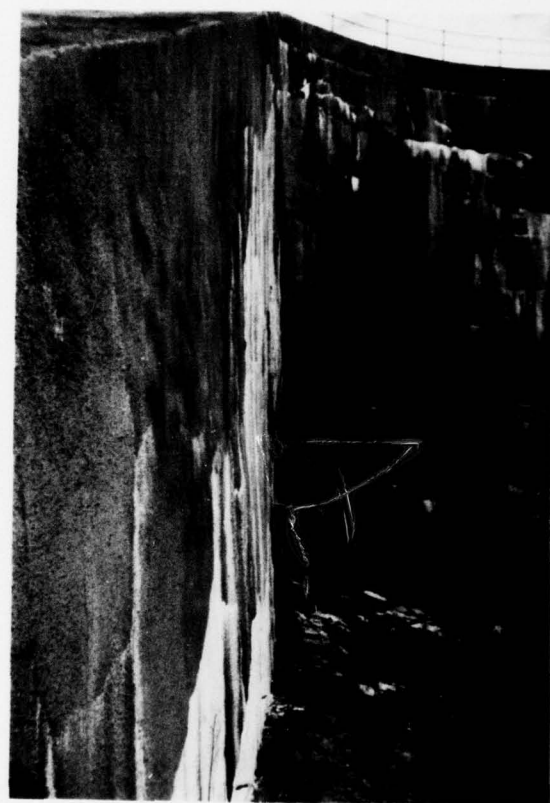
Third Arch Viewed from Top of Dam  
Looking North

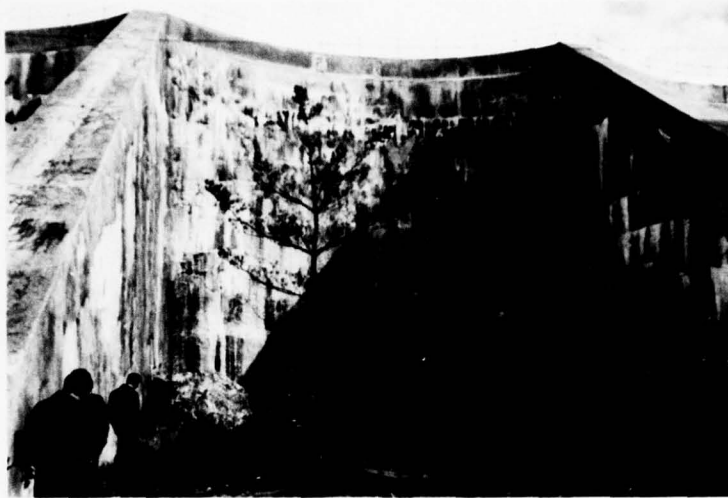
Second Arch and low-level Outlet Control Building

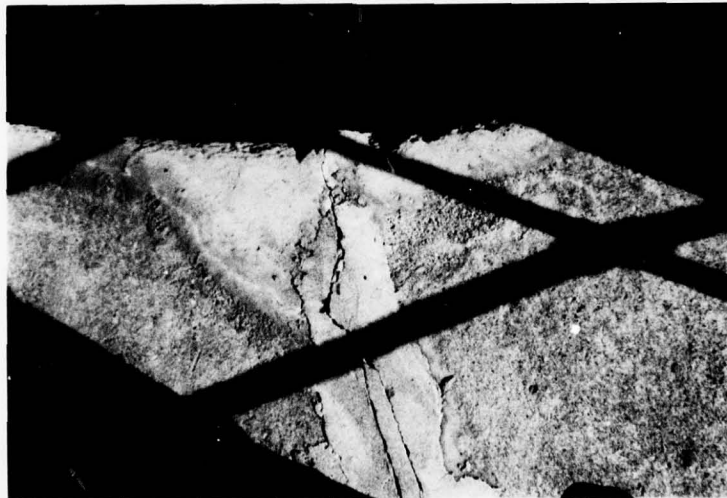
Top of Dam - Arched Section  
Note Crack

- b. Structural Cracking cracking at crest of buttress sections  
completely thru top of dam (see photo), cracks were  
repaired and have cracked again
- c. Movement - Horizontal & Vertical Alignment (Settlement)   
no problems observed

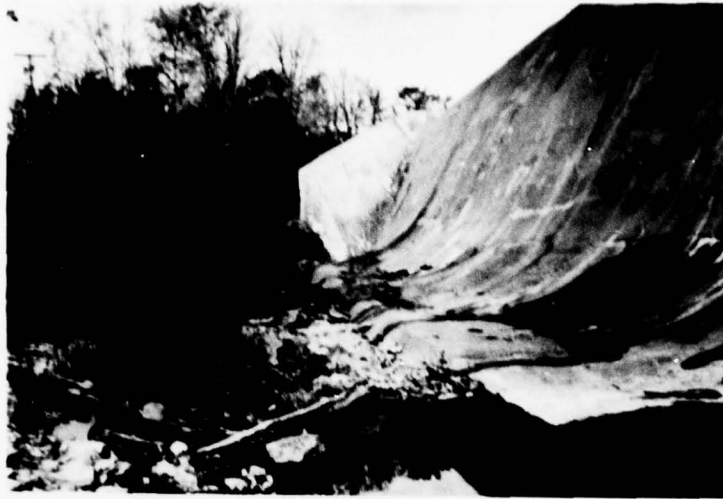
Spillway Looking North

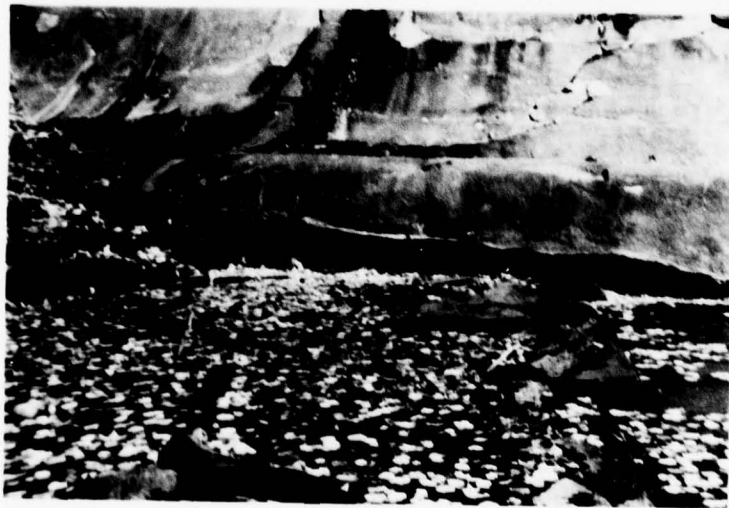
Base of Spillway

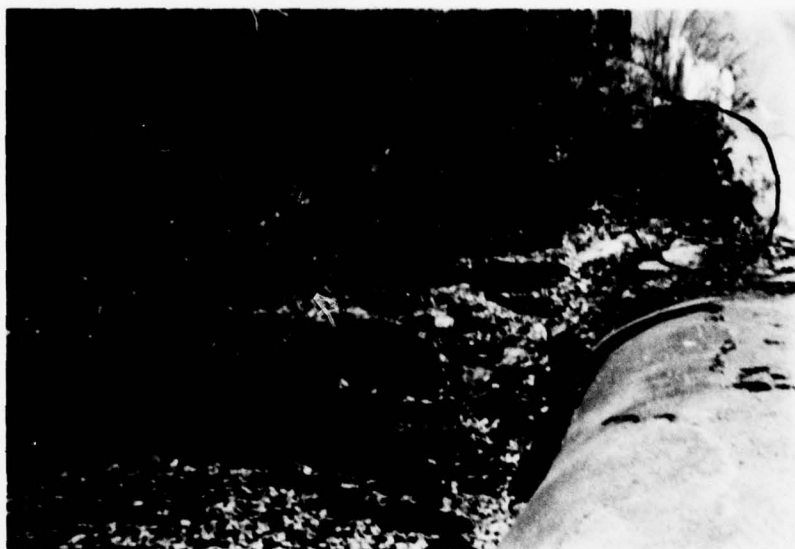
Base of Spillway Looking North  
Note Void in Circled Area

- b. Erosion of the upstream face near the north buttress of the spillway requires repair and placement of erosion protection material. The void observed at the toe of the north buttress of the spillway (downstream face) must be periodically monitored to determine if further movement is occurring.
- c. Remove debris and silt which has accumulated in the outlet channel of the 36 inch reservoir drain.
- d. Periodically monitor the steep slopes of the earth embankment to determine if remedial measures are required to prevent erosion or sloughing of these slopes.
- e. Initiate a program of periodic inspection and maintenance of the dam and appurtenances. Document this information for future reference. Also, develop an operations manual.

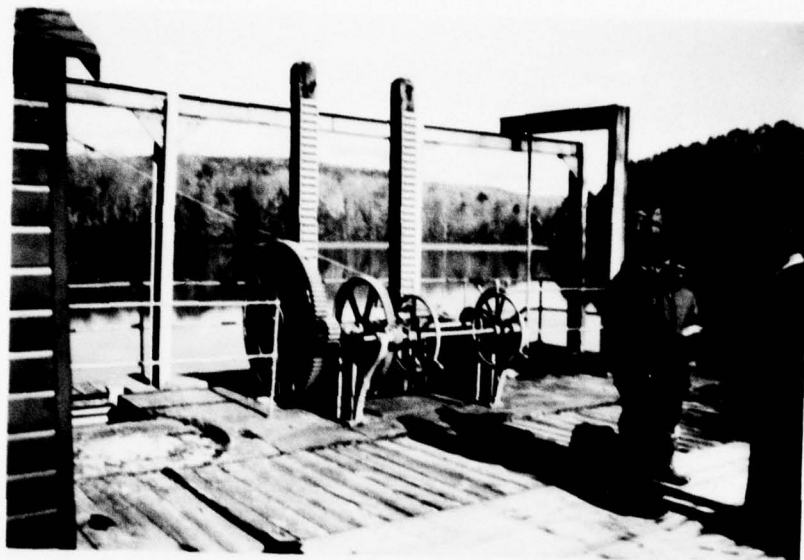
Penstock Control Mechanism
